**O & M INSPECTION REPORT
FOR NAVIGATION AND SHORE PROTECTION PROJECTS**

1. Project Name: Manele SBH
2. Date of Inspection: August 1, 2002

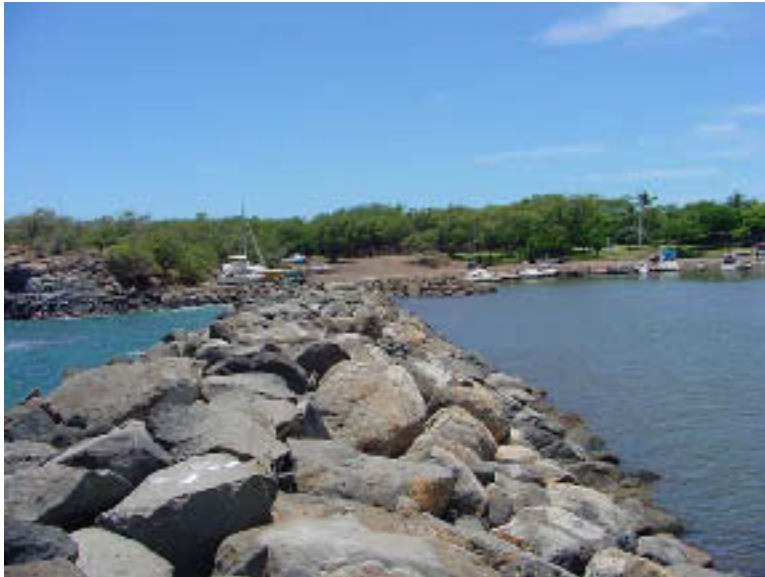
A. Overview at start of project from trunk to root. Ocean side is to the left, and harbor side is to the right.

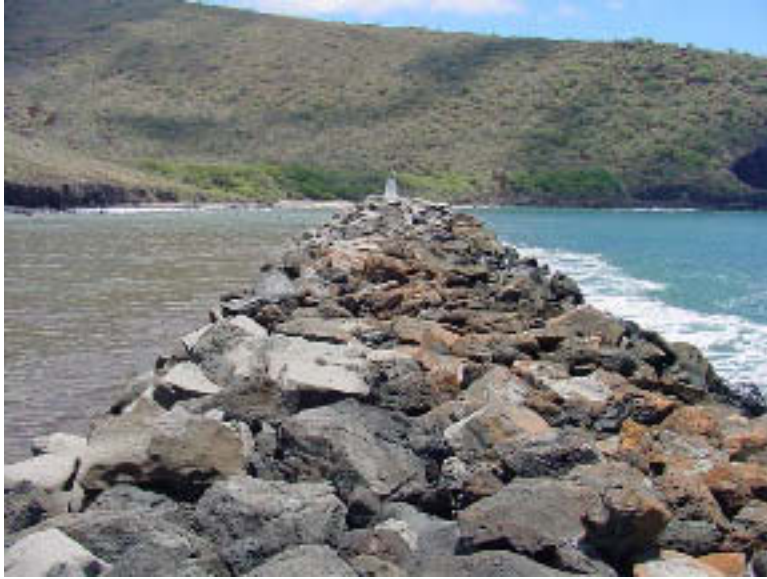
B. Overview at end of project from trunk to head. Ocean side is to the right, and harbor side is to the left.

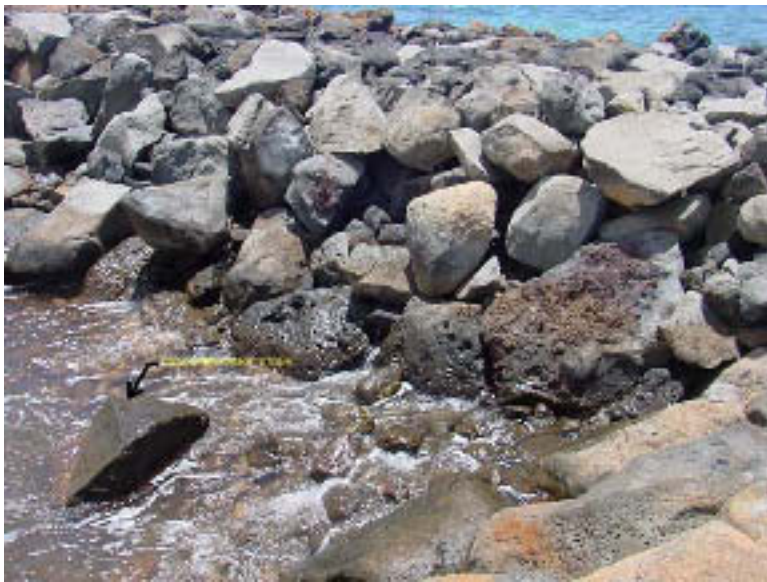
C. Sta. 1+09, HS, dislodged armor stone 3' from toe. Void is half way up side slope.

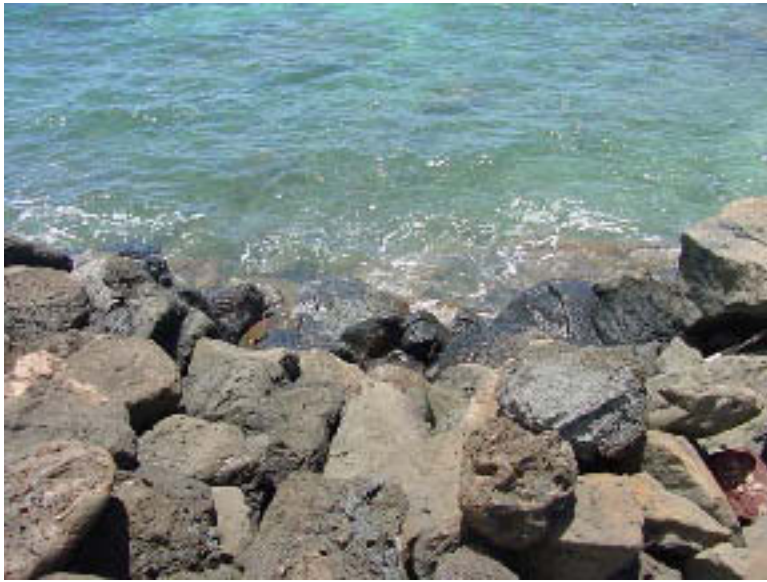
D. Sta. 1+40, OS, side slope failure. 8 LF hinge to toe under layer exposed.

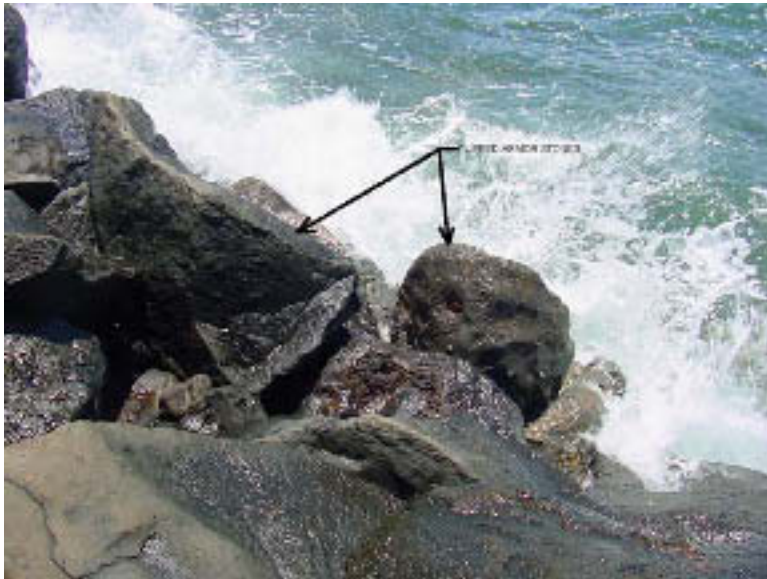
E. Sta. 2+20, OS, 2 flipped armor stones on side slope.

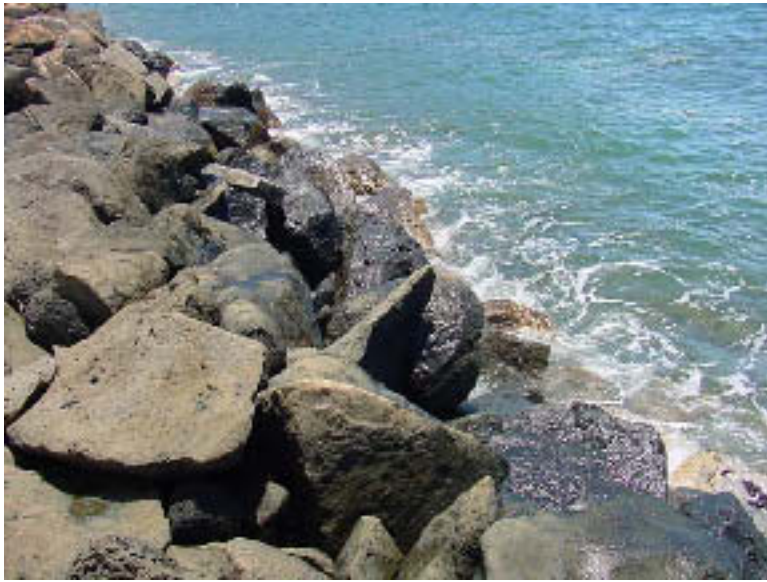
F. Sta. 2+44, OS, side slope steepening. Void under side slope. Under layer not exposed.

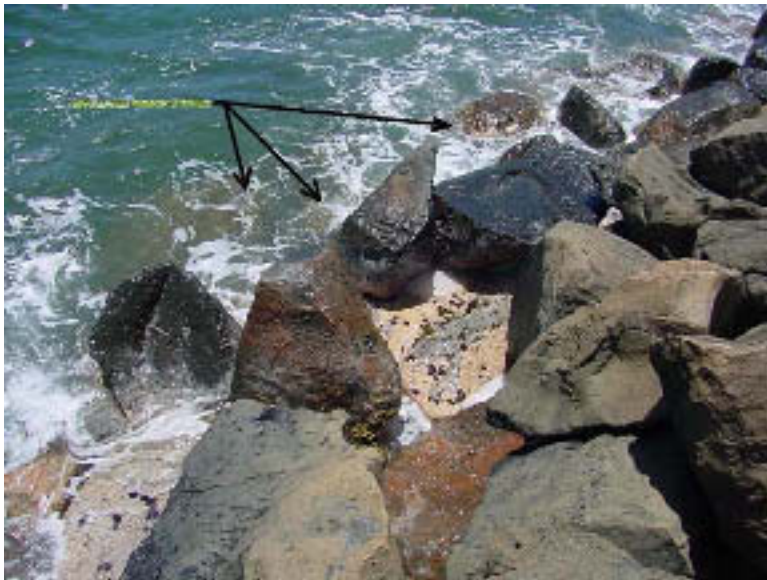
G. Sta. 2+80, OS, Dislodged armor stones at water line.

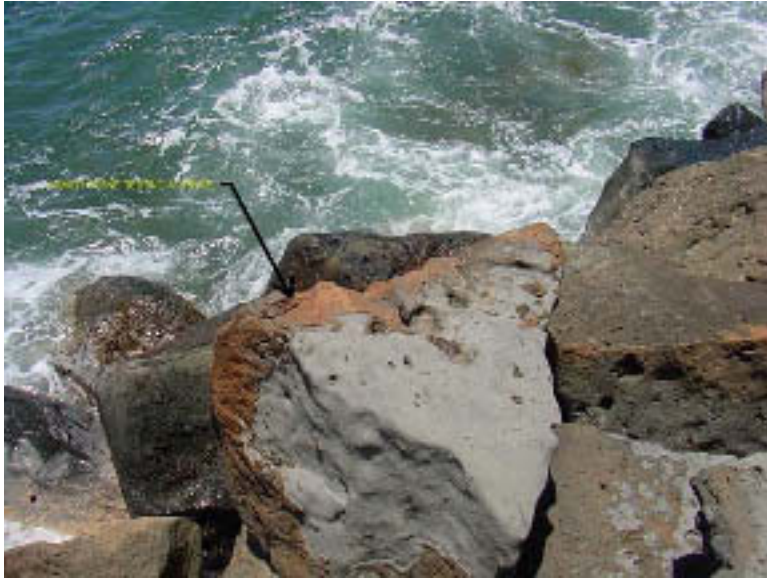
H. Sta. 3+01, OS, 1 armor stone resting at hinge.

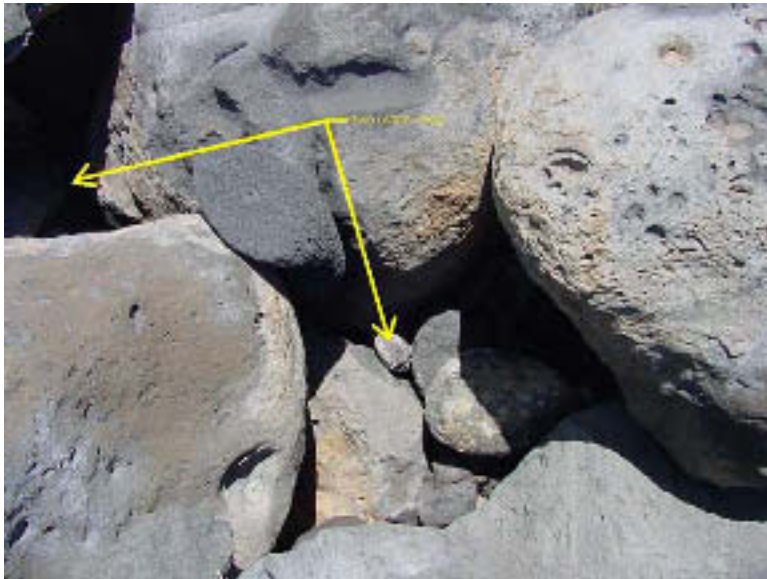
I. Sta. 3+40, 2 large voids at center line of crest.

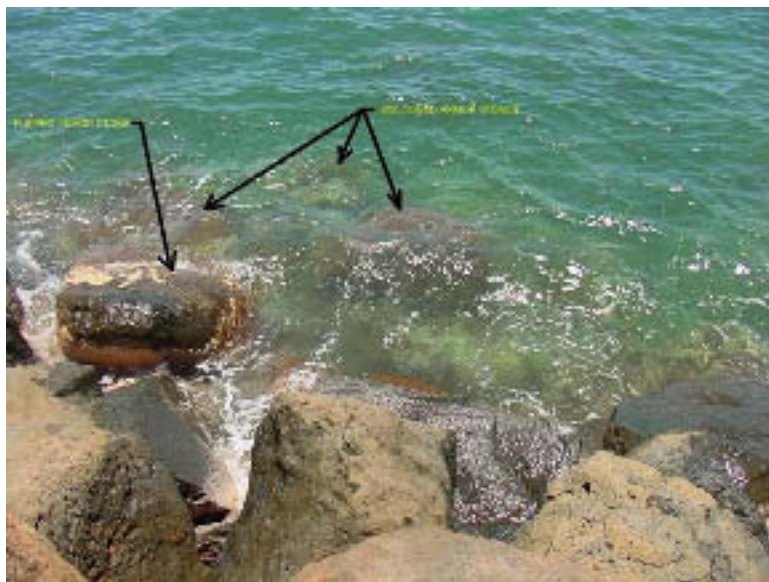
J. Sta. 3+74, OS, 3 dislodged armor stones at toe. 1 flipped armor stone at hinge.

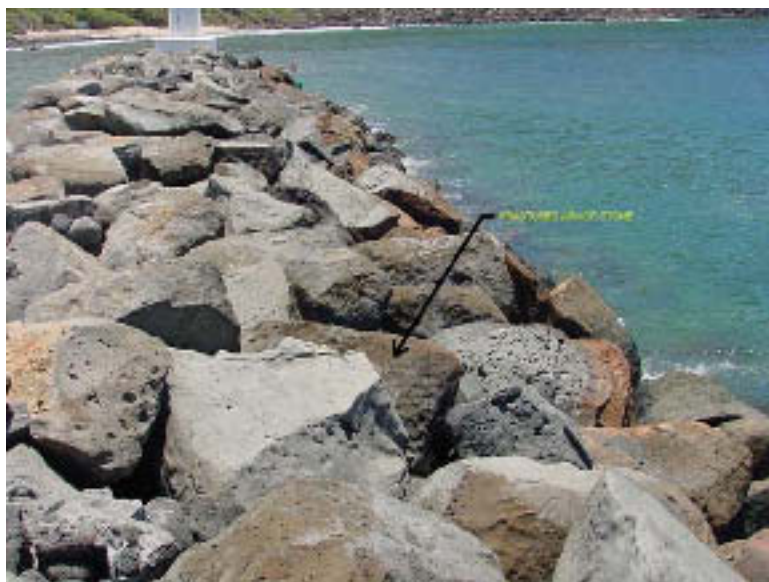
K. Sta. 4+01, OS, 1 fracture at hinge.

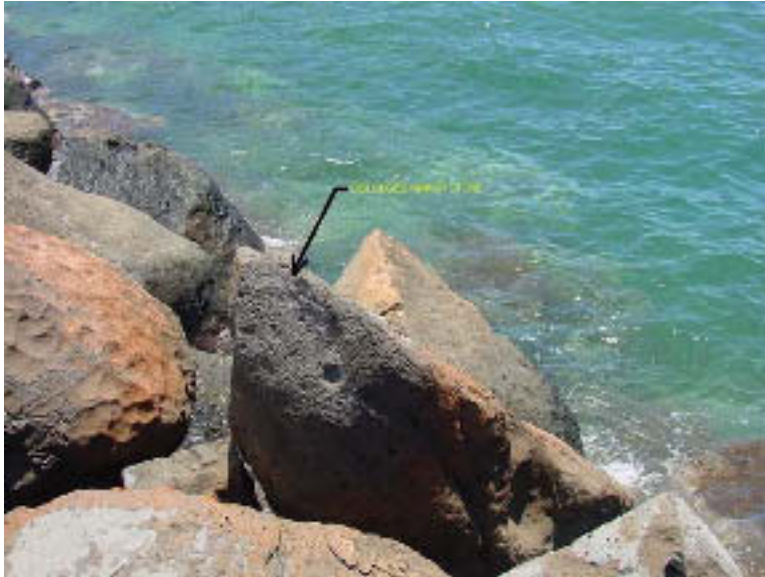
L. Sta. 4+22, OS, 1 armor stone dislodged resting on side slope.

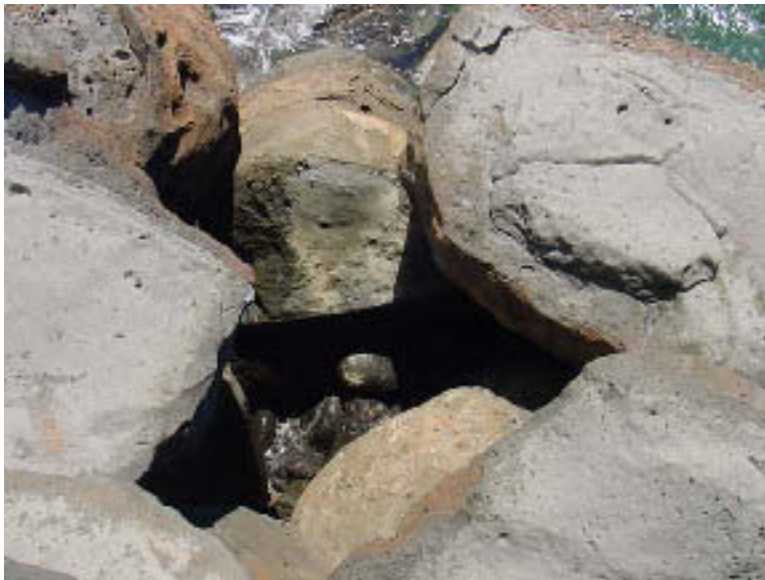
M. Sta. 4+51, OS, large void with exposed under layer. Dislocated armor stone is resting on side slope, which is also steepening.

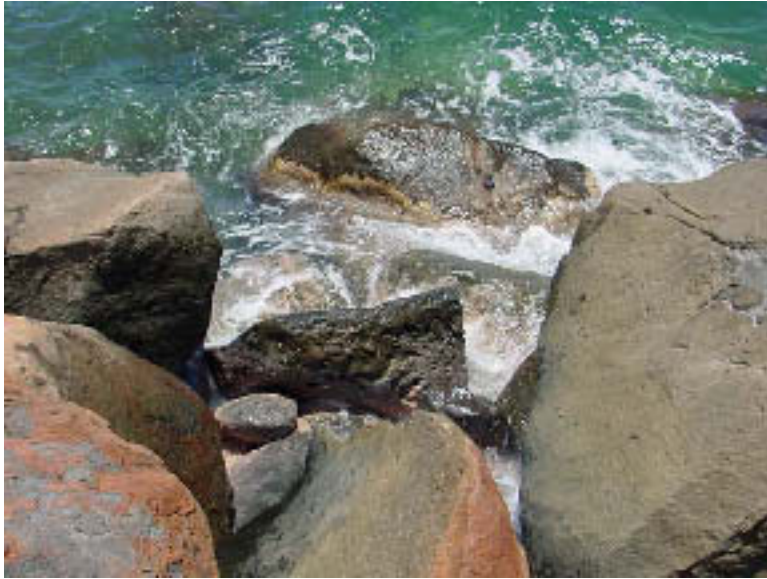
N. Sta. 4+86, OS, side slope failure with under layer exposed. 2 dislodged armor stones in the water at the toe.

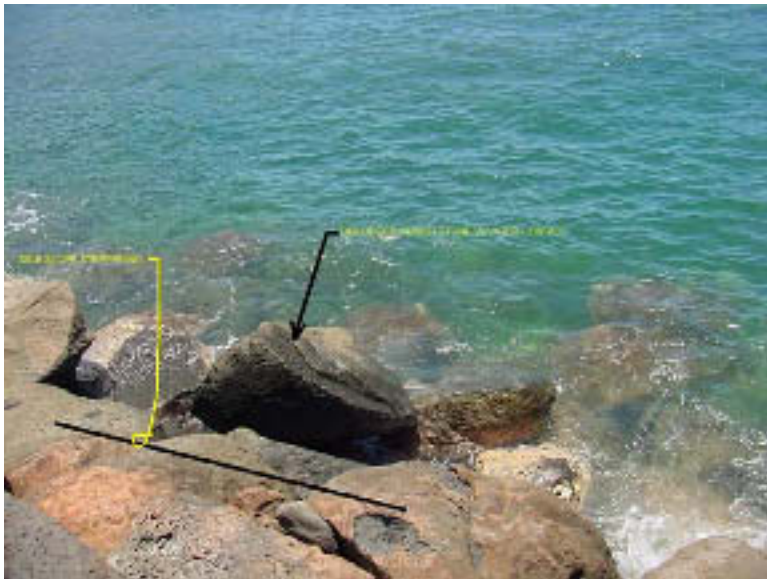
O. Sta. 5+14 to Sta. 5+42, OS, side slope steepening. Dislodged armor stone at toe with poor contact.

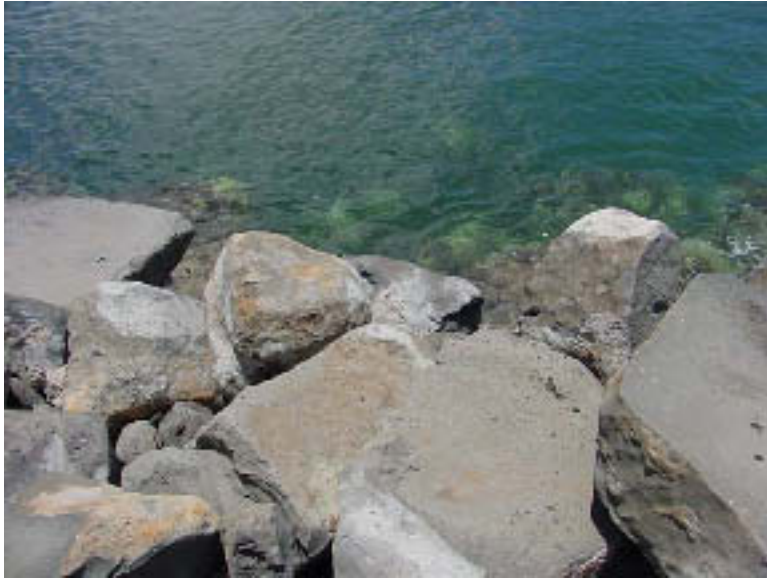
P. Sta. 5+67, HS, structure flattening and steepening at water line.

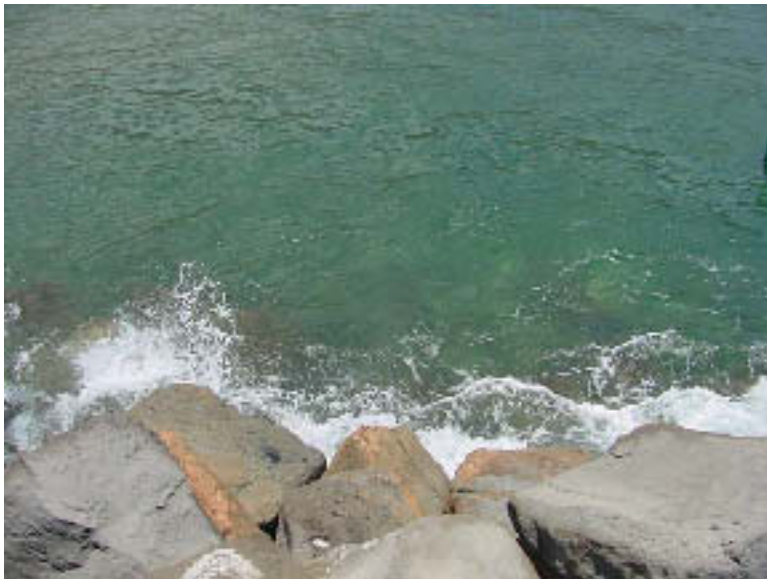
Q. Sta. 5+87, picture taken from 22 degrees HS to 22degrees OS at the head of the structure. There is a possibility of a missing layer of armor stones at water line.

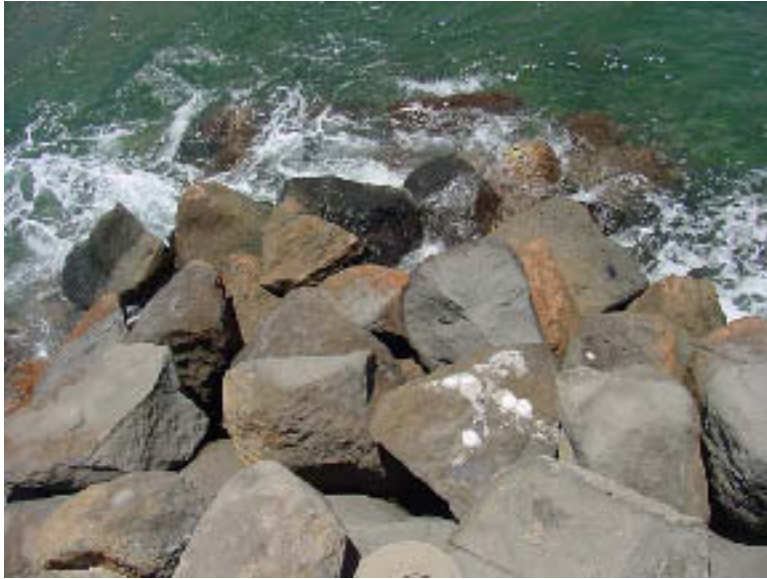
R. Sta. 5+87, picture taken from top of monument at 20 degrees HS to center line of head at 0 degrees. There is a possibility of a missing layer of armor stones at water line.

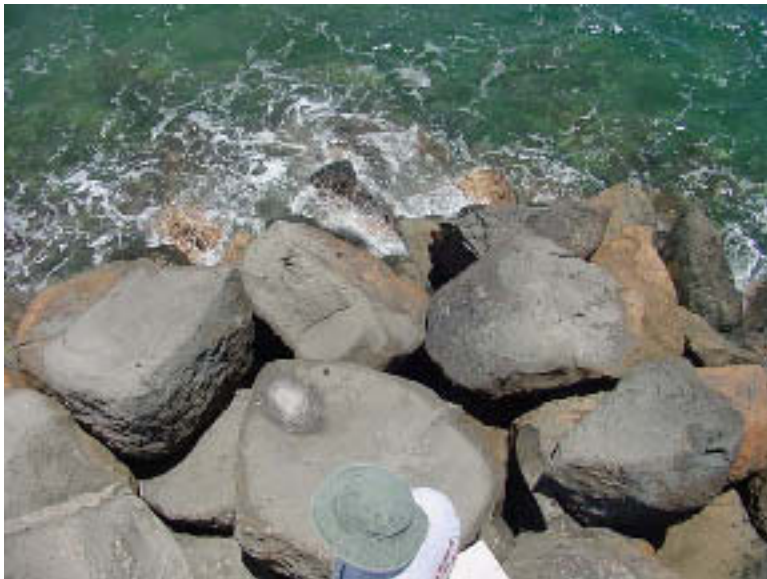
S. Sta. 5+87, picture taken from top of monument at center line of head at 0 degrees to 22 degrees OS. There is a possibility of a missing layer of armor stones at water line.

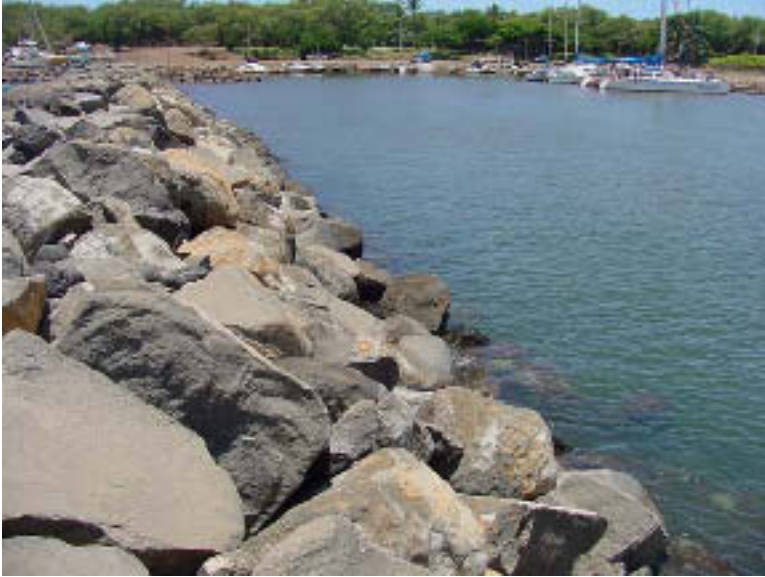
T. Sta 4+98, HS, 1 dislodged armor stone at toe.
